Aardvark Mark IV Joint Services Flail Unit (MKIV)

Capabilities Demonstration

1-10 October 2001

January 2002

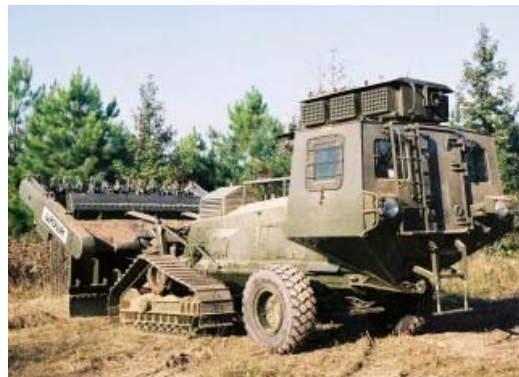
Picture 1 – Mark IV Joint Service Flail Unit

The MKIV system consists of an armored New Holland tractor and a specialized flail assembly. The tractor has a 160hp 6-cylinder in-line turbo charged diesel engine and a 3-speed power take off (PTO). The flail assembly is mechanically driven via a heavy-duty gearbox. The flail can clear a path 3m wide and consists of 72 chains with striker tips.

The Aardvark Clear Mine, Limited (a private British company) of Scotland has been designing and producing a variety of mechanical minefield clearance machines for seventeen (17) years. The Mark IV Joint Services Flail Unit (MKIV, see picture 1 on the next page) has been in production since 1999, and it is the product of years of improvement to the Aardvark Flail System basic design. Improvements affect engine performance, flail depth, flail control, steering control, operator safety, operator comfort, navigation and maintenance. The steering control (dual steering) can be switched from the operator (in the left seat) to the operator (in the right seat) and vice versa. Because the MKIV creates dust and works in many hostile environments,

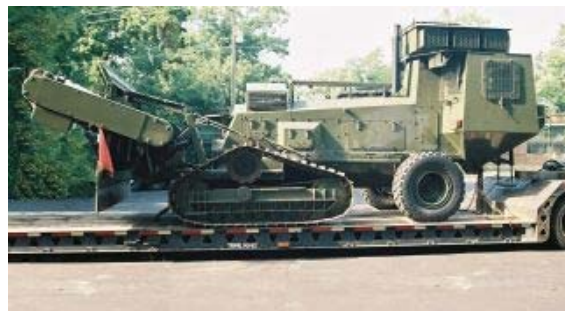
Picture 6 – MKIV on trailer

The system was transported by a sea vessel, then by a commercial truck and finally by a government truck to the NVESD/CM test site. Picture 6, below, shows the MKIV on a trailer. The system is transportable by truck, rail, vessel and C-130 aircraft (or other larger aircraft). Due to the width of the flail unit, over road transport restrictions are imposed, and some restrictions may be imposed for rail as well. For transport via a C-130 aircraft, the system must be broken down somewhat (the flail removed from the tractor and the cab roof filter removed, etc.). These procedures are documented in the system technical manual. The system has NATO standard tie down and lift points. The system can maneuver via track or tire configuration and can be changed from one configuration to another within a couple of hours. The tire configuration is better suited for long distance travel as compared to the track configuration for short distances. During mobility and maneuverability tests, the system performed very well. The MKIV system demonstrated the capability to be transportable by truck, sea vessel and aircrafts.

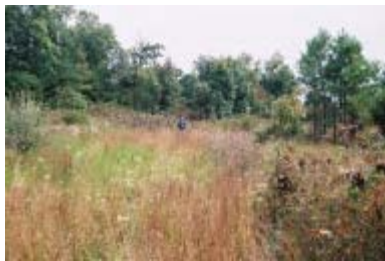
Picture 10 – Cat. 2 prior to flailing

This site consisted of moderate vegetation with brush and saplings (up to 6cm in diameter and ~2.5m in height) on light rolling hard ground. See picture 10, below. The Aardvark MKIV operated at two different speeds while cutting category 2 vegetation. For the first two passes, the MKIV traversed the site at a 1200m per hour and the last pass was traversed at a 191m per hour. At 1200m/hr, the ground penetration depth was ~14cm and at 191m/hr, the ground penetration depth was ~20cm. Picture 11 shows the MKIV cutting category 2 vegetation. The ground was completely mulched and powdery with occasional stubbles ranging from 5cm to 7.5cm in height. Picture 12 below shows the site after the MKIV cut the vegetation. The MKIV cut 479.7m² in 26 minutes with a cutting rate of 18.45m² per minute. The MKIV lost two chains and one flail head while cutting category 2 vegetation. The MKIV demonstrated the capability of clearing category 2 vegetation.

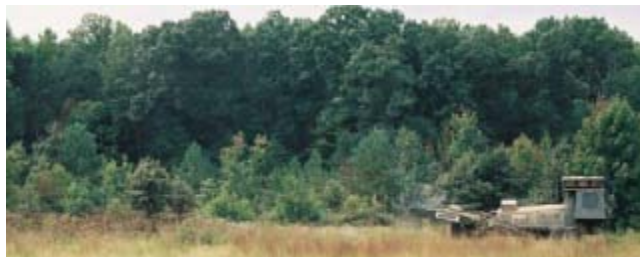
Picture 13 – Cat. 3, prior to cut

Category 3 consisted of moderate vegetation and brush with saplings and trees up to 10cm on a slightly sloped terrain with lots of ruts. See picture 13. Category 3 was cut at A4 crawler gear, at which the MKIV traveled at 191m/hr. See picture 14. In a 30-minute time

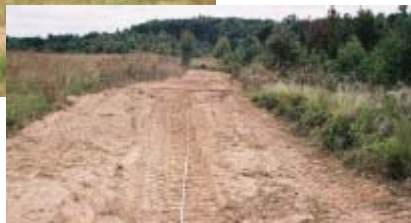
frame, the MKIV cut an area of 80m x 6m, with a cutting rate of 16m² per minute. The ground was turned into powdery mulch, see picture 15. Ground penetration was between 20cm to 30cm. The MKIV left occasional tree trunks and scattered pieces of trees in the lane. The tree trunks were ~7.5cm in height. During this vegetation clearance operation, the MKIV lost one chain, seven chain links and two cutting heads. The MKIV demonstrated the capability of clearing category 3 vegetation.

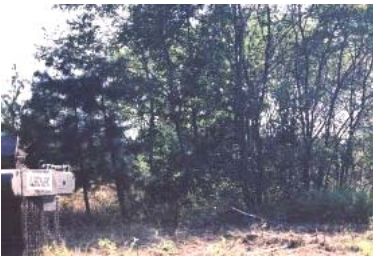
Picture 16 – Category 4

Although this site was considered to be category 4, the terrain was fairly level and the majority of the vegetation was considered category 3 and below, which is 10cm in diameter or less. See picture 16. This site contained some trees that were larger than 10cm diameter and the largest tree was 23cm in diameter. The operator used A2 crawler gear to cut this vegetation. The system traversed the site at 92m per hour. The flailing depth of the MKIV for this operation ranged from 20cm to 30cm with the average at 27cm. During a 30-minute time frame, the MKIV cut an area of 22m x 8m, with a cutting rate of 5.87m per minute. See pictures 17, 18 and 19. The ground was turned into a bumpy powdery field, see picture 20. The MKIV shredded and left most stumps in the ground, but one stump (1.3m long) was dug out of the ground. Even though the system was designed to tackle 15cm diameter trees or less, the MKIV demonstrated the capability to clear a 23cm diameter tree. During this operation, the MKIV lost two chains, seven links, two flail heads, and one weight. The MKIV demonstrated the capability of cutting category 4 vegetation.
